Comprehensive Monitoring and Evaluation of Ballast Tank Coatings Integrity for Life Prediction and Condition Based Maintenance

September 29, 2000

NRL/MR/6136--00-8492

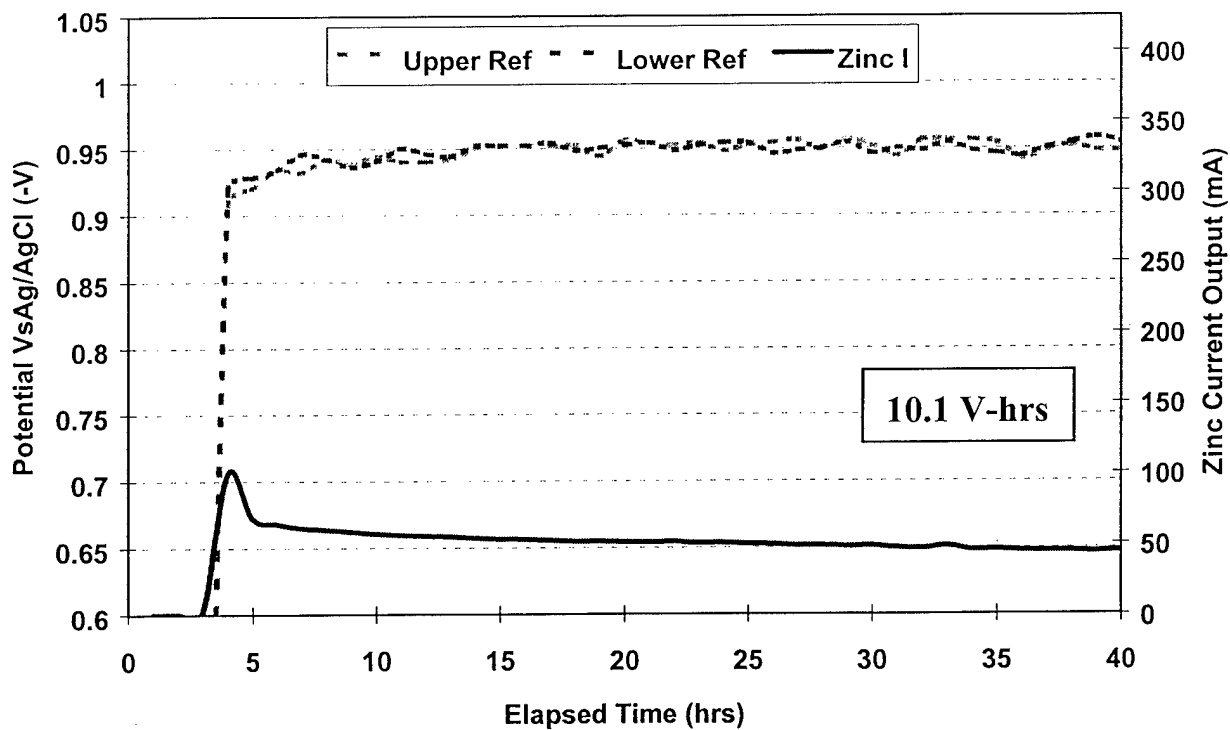
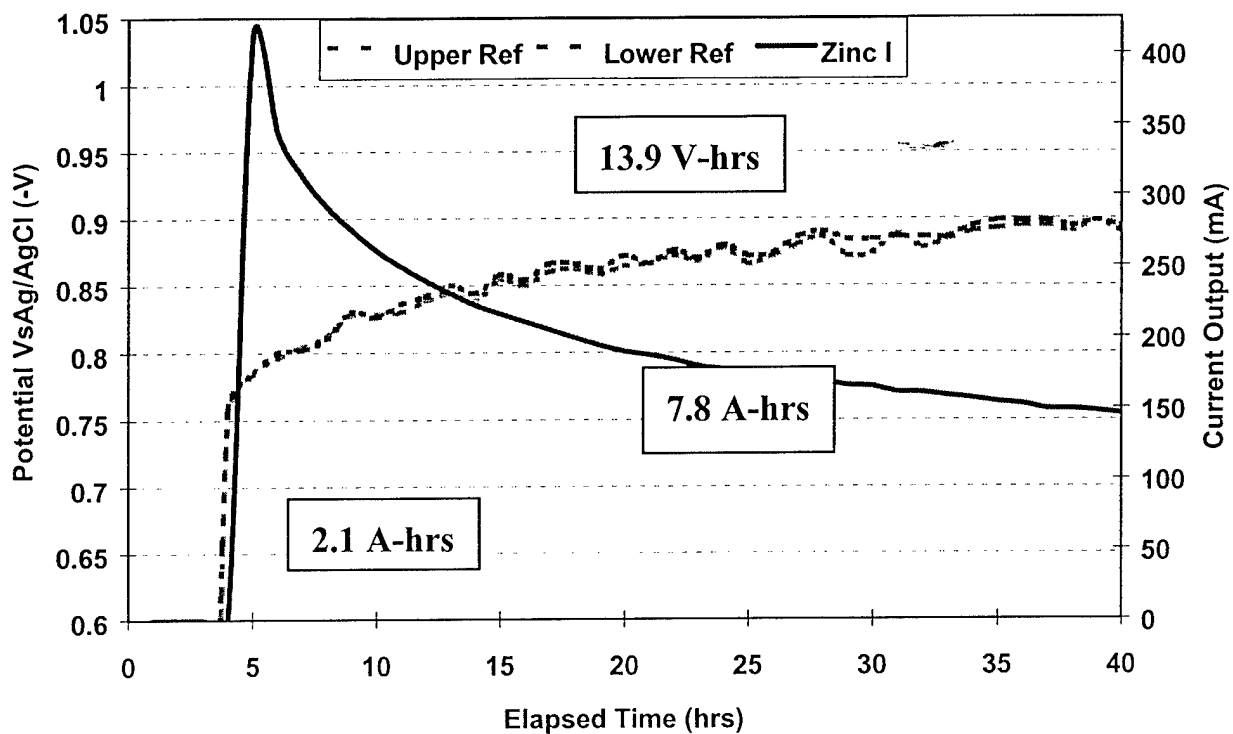
The curves in figure 5 show an example of a data set for a filling episode in two tanks with widely variable coatings conditions. Historically, these were two adjacent tanks on the same ship, with similar geometry and the same quantity of zinc anodes. The instrumented zinc/reference cell CBM sensors were installed in relatively the same locations with reference cells located 1 m above the bottom and 3 m respectively. The upper curve (a) represents data for a 1-2 year old tank coating, while the lower (b) shows data from a 9-10 year old coating system. In the relatively new condition (a), the reference cell data showed immediate tank polarization along with a corresponding initial zinc current spike. Once polarized the zinc current dropped to a low steady maintenance current of approximately 50 mA. In the deteriorating condition (b), the tank polarized considerably slower and did not achieved the magnitude of polarization nor a steady state within the reported tank filling episode. The corresponding zinc current showed an initial spike nearly 4 times that of figure 5a and then gradually declined to mirror the slow polarization behavior. The final current output, of 150 mA, was still 3 times that of the newly coated tank for the same duration. Comparison of the integrated zinc amp-hrs output indicates a significantly increased consumption of the anode in tank (b) and clearly illustrates the differences in tank condition over the relatively short time period used for this evaluation. The integration area was limited to the area under the curve more electro-negative than - 600mV.

Figure 5. (a) Top - Shows Potential and Instrumented Zinc Data for 1-2 Year Old Tank Coating, (b) Bottom - Shows Potential and Instrumented Zinc Data for 9-10 Year Old Coating.

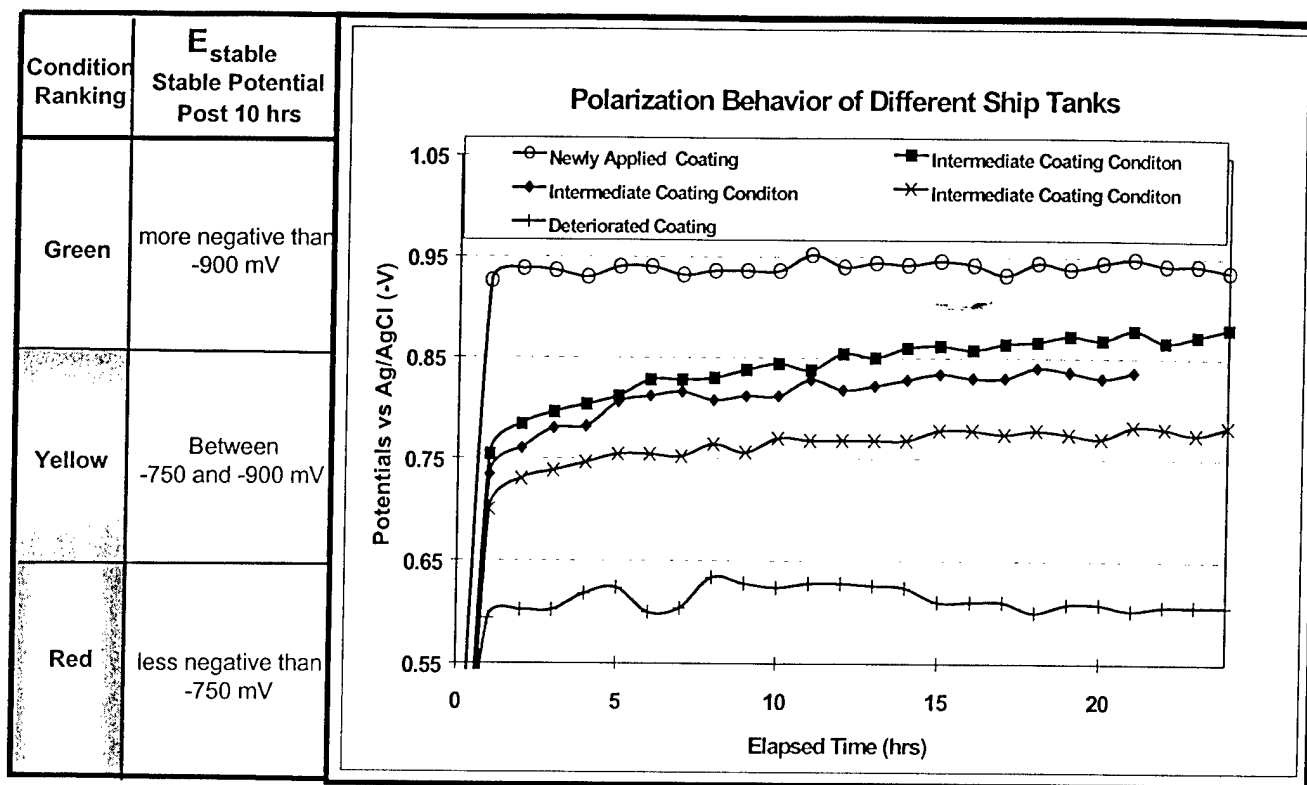
Figure 6 shows the upper reference cell data acquired from five different ship tanks using the two reference cell configuration. The five curves were taken during a single filling event and clearly discerned different tank states. The potential levels could be initially graded into three condition rankings, which corresponded to a traffic light scenario where green tanks were trouble free (more electro-negative than -900 mV) and required no maintenance. Tanks which fell into a yellow zone (–750 mV to –900mV) were indicative of increased activity placed on the cathodic protection system and had the requirement for additional current to protect more bare or degrading coatings area. Tanks with nearly freely corroding conditions, fell into the red zone (more electro-positive than -750 mV) and had an unacceptable percentage of corrosion damage. Additionally, the red tanks most likely had a failed or significantly overworked cathodic protection system.

Because this is a filling event, the reference cells begin to read when they become immersed in seawater. The resultant polarization verses time plot provides not only the extent of polarization, but also identifies those tanks that polarize immediately verses those which polarize slowly. Given the fixed tank area and an initial state, each filling episode provides a new polarization curve representative of conditions that currently exist and correspondingly provides trend data for long-term prediction. Detailed analysis of the polarization curve, which is under development, can provide information pertaining to further fine ranking within each of the three major categories and allow for better refinement of coatings damage percentages/tank condition.

Figure 6. Basic Tank Condition Ranking Using Potential Verses Time Data.

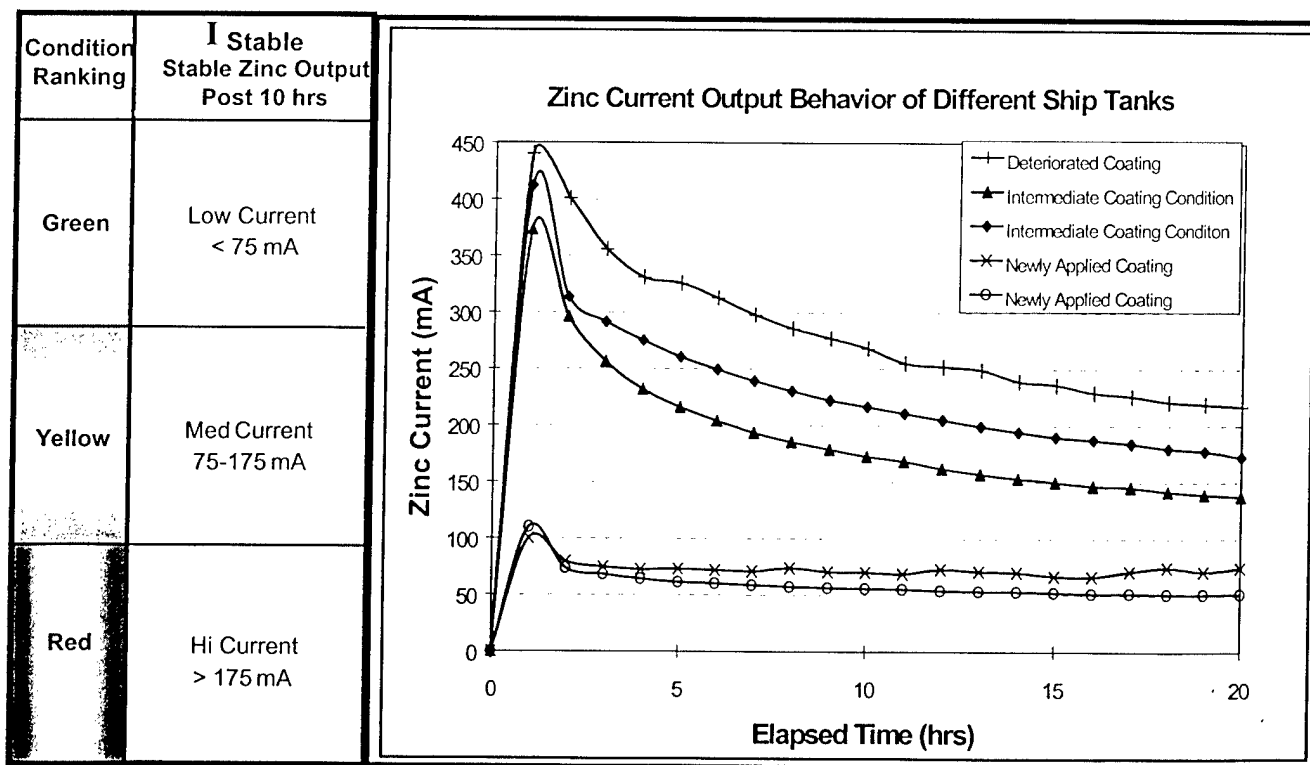
The instrumented zinc analysis, as shown in figure 7, added the cathodic protection component into the equation. The tanks with newly painted surfaces and low cathodic protection requirements drew a minimal amount of current from the anode. The initial current demand, along with the subsequent drop-off associated with calcareous deposition, were measured and utilized to provide an indicator for long-term requirements on the system. In the tanks with some coatings breakdown and more exposed metallic area, the anode responded, as expected, and provided an increasing level of current. Once the zinc output exceeded 75 mA, that tank condition was degraded to the yellow condition state and correspondingly, when the output exceeded 175 mA the condition was changed to a red state.

Figure 7. Basic Tank Condition Ranking Using Zinc Anode Current Output Verses Time.

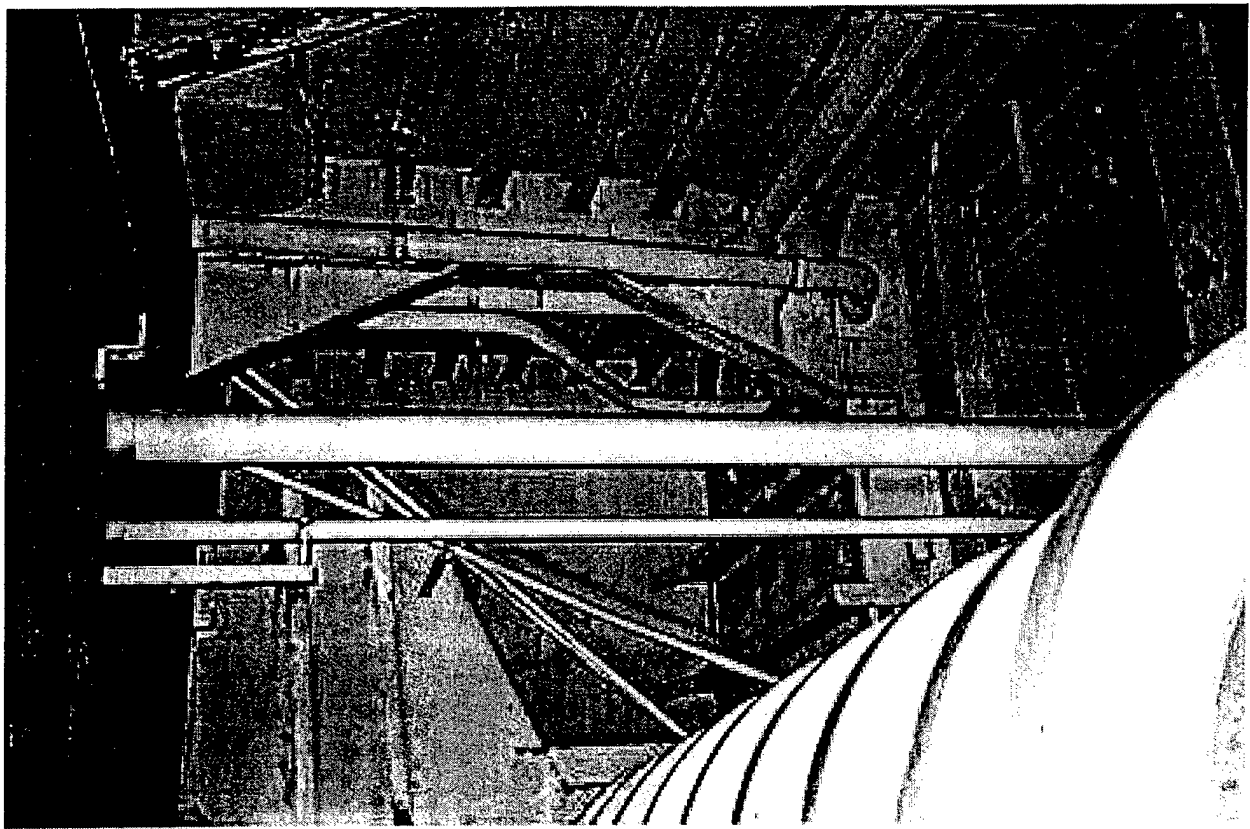
Tanks ranked according to potential and current measurement scenario are shown in figures 8-10. The adequate preservation state, i.e. those in the green condition, are relatively easy to identify, both from the data and from visual observation. Under this condition, tanks are readily cathodically protected, well coated and typically have less than 1% coatings damage. No periodic inspection is warranted and no consideration need be given toward maintenance. The marginal preservation state (yellow condition), is beginning to show signs of damage, principally at known problem areas, such as structural support beams and edges. These damage percentages generally are from 1-3% and indicate a "monitor"

Figure 8. Photograph of "Green" Ballast Tank After 18 Months Service.

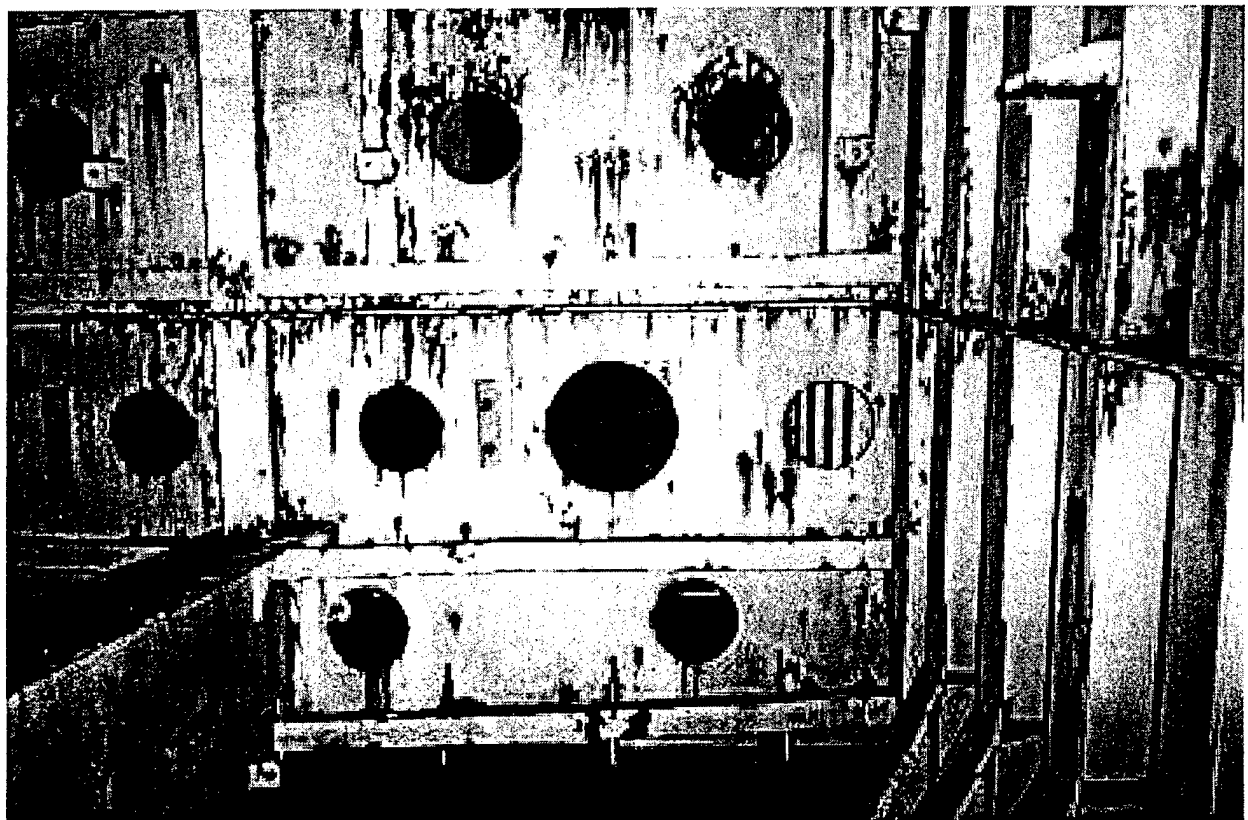
situation, where there is still sufficient cathodic protection and no widespread coatings damage. In this state, tanks can be: a) just monitored, b) touched up to improve conditions, c) given additional cathodic protection as the tank polarization drops or d) placed into future scheduled maintenance plans. Additionally, these tanks may receive a remote visual inspection and periodic oversight to track the changes. Once tanks reach a red state, there is considerable coating loss and visually the tanks appear deteriorated.

Figure 9. Photograph of "Yellow" Ballast Tank After 11 Years Service.

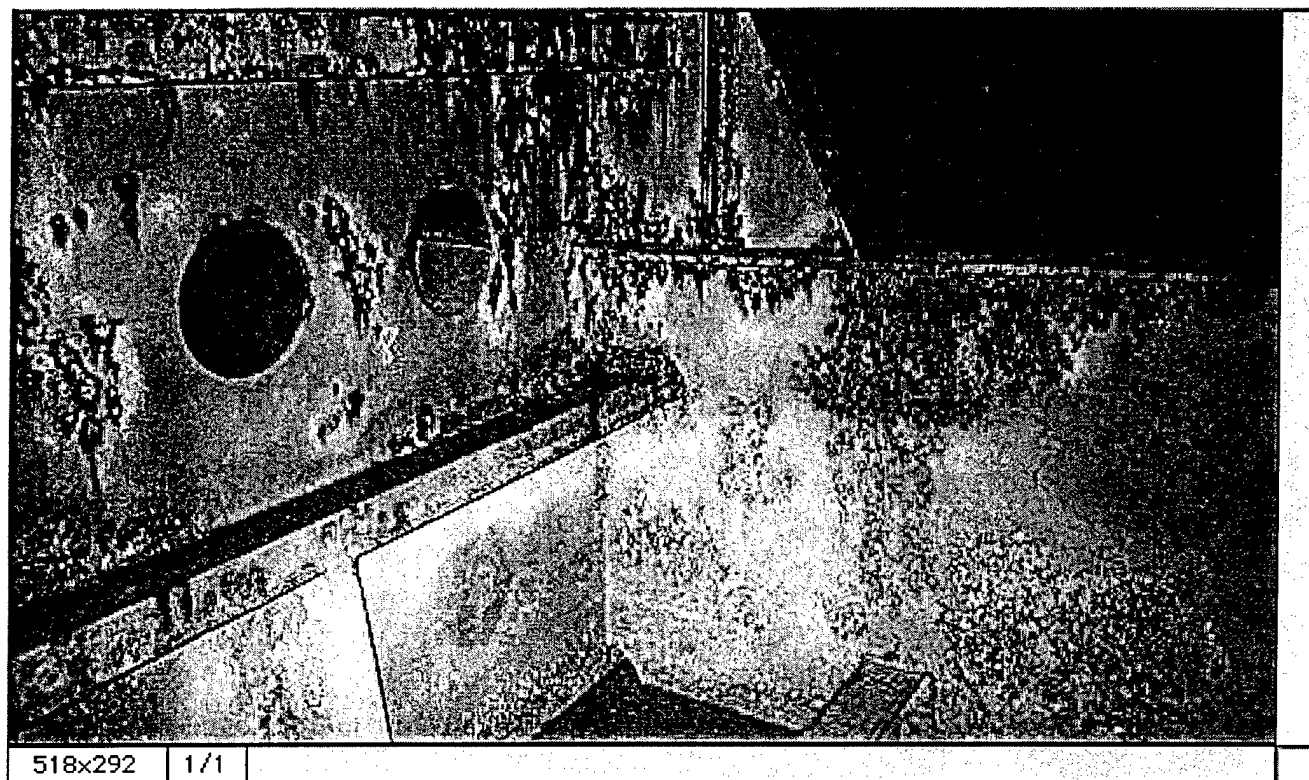
As a coating degrades, there is a gradual reduction in the dielectric nature of the coating barrier, which places increasing demand on the cathodic protection system to protect the surfaces. The current output ultimately increases until a maximum output level is obtained and the system can no longer maintain the same level of polarization. At this maximum output value, both the anode and reference cells provide an indication that the cathodic protection level can not be sustained. In this red condition, the anode current will remain greater than 175 mA, while the potential may fall off to or never move from a freely corroding condition. Tanks in the extreme red condition are most likely sustaining structural corrosion damage and require immediate attention.

Figure 10. Photograph of "Red" Ballast Tank After 11 Years Service.
